## **Fast, Effective & Economical : Asia and Malaysia's 1<sup>st</sup> Re-directive Solutions for Riverbank Repairs and Water Detention at Sg Pedu, Kedah for agriculture needs in dry season**

Kwok Wing Leong<sup>1</sup>, John McCullah<sup>2</sup>

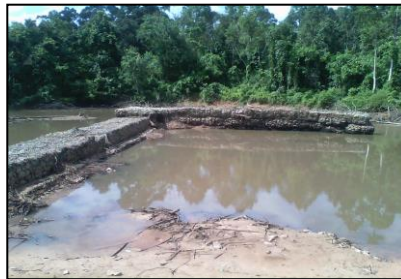
A multi-level gabion barrier was constructed across the river at downstream of the pump intakes to provide (2m) depth of water detention to facilitate the pumping needs. However, problems develop during high waters in the rainy season when erosive forces were deflected by the gabion barriers across the river, “scouring away” land on the adjacent riverbank. The situation is further aggravated when waters are discharged from the Pedu Dam especially during the rainy season.

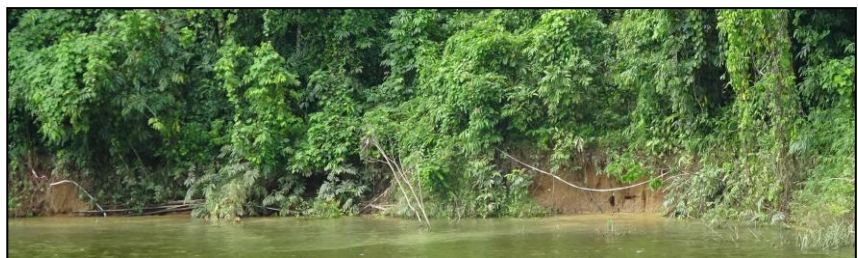
Rock revetment was employed at eroded riverbank sections which resulted in further riverbank erosion both at location and at downstream of repairs possibly attributed many factors including poor rock gradation, installation site control and the possibility of the development of secondary river currents during high flows from energy deflections as a result of “deepening from centrifugal friction cells” (research by Rob Davinroy, St. Louis).

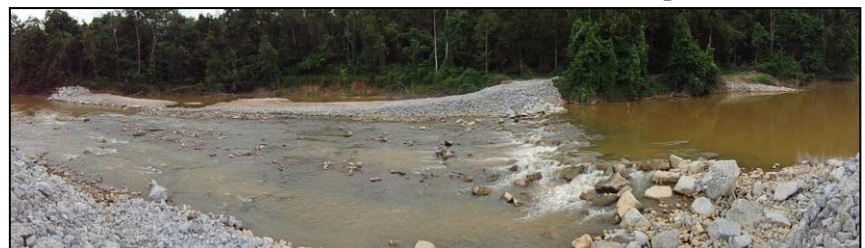
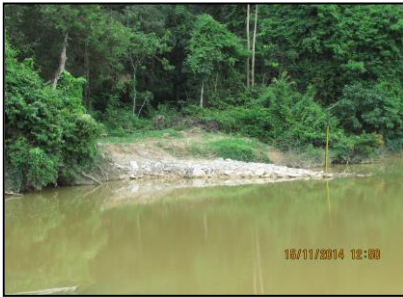
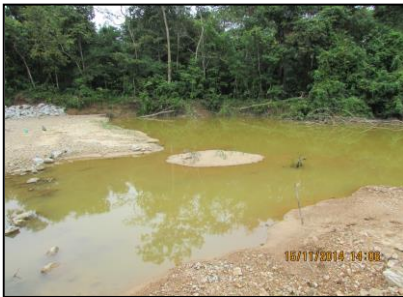
**Site visit 15-11-14 photos:**

**Post Construction site visit on 15 November 2014:** Two months after completion and after several “high flows” sees the Newbury Rock Riffle

apron adjusting to the flow patterns. The Bendway Weir has performed well as can be observed on the downstream riverbank aggradating with good signs of deposition and vegetative growth.

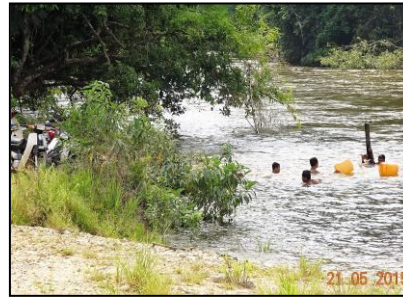
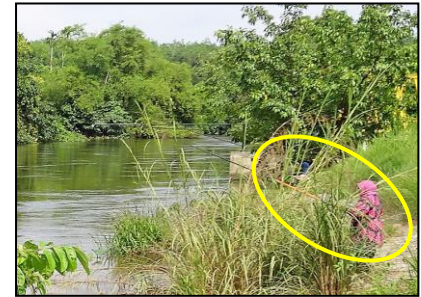
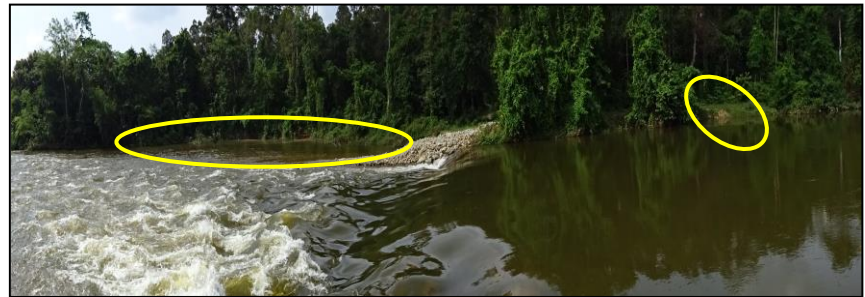
Site visit 21-5-15 photos:

**Post Construction site visit on 21 May 2015:** Eight months from project completion on installation of Re-directive Method of Bendway Weir, Newbury Rock Riffle & Longitudinal Peak Stone Toe Protection.
