Need for ESCP in Agricultural Sector – The case of Lojing

Moh Shalahuddin bin Adnan

Faculty of Civil and Environmental Engineering,

Universiti Tun Hussein Onn Malaysia

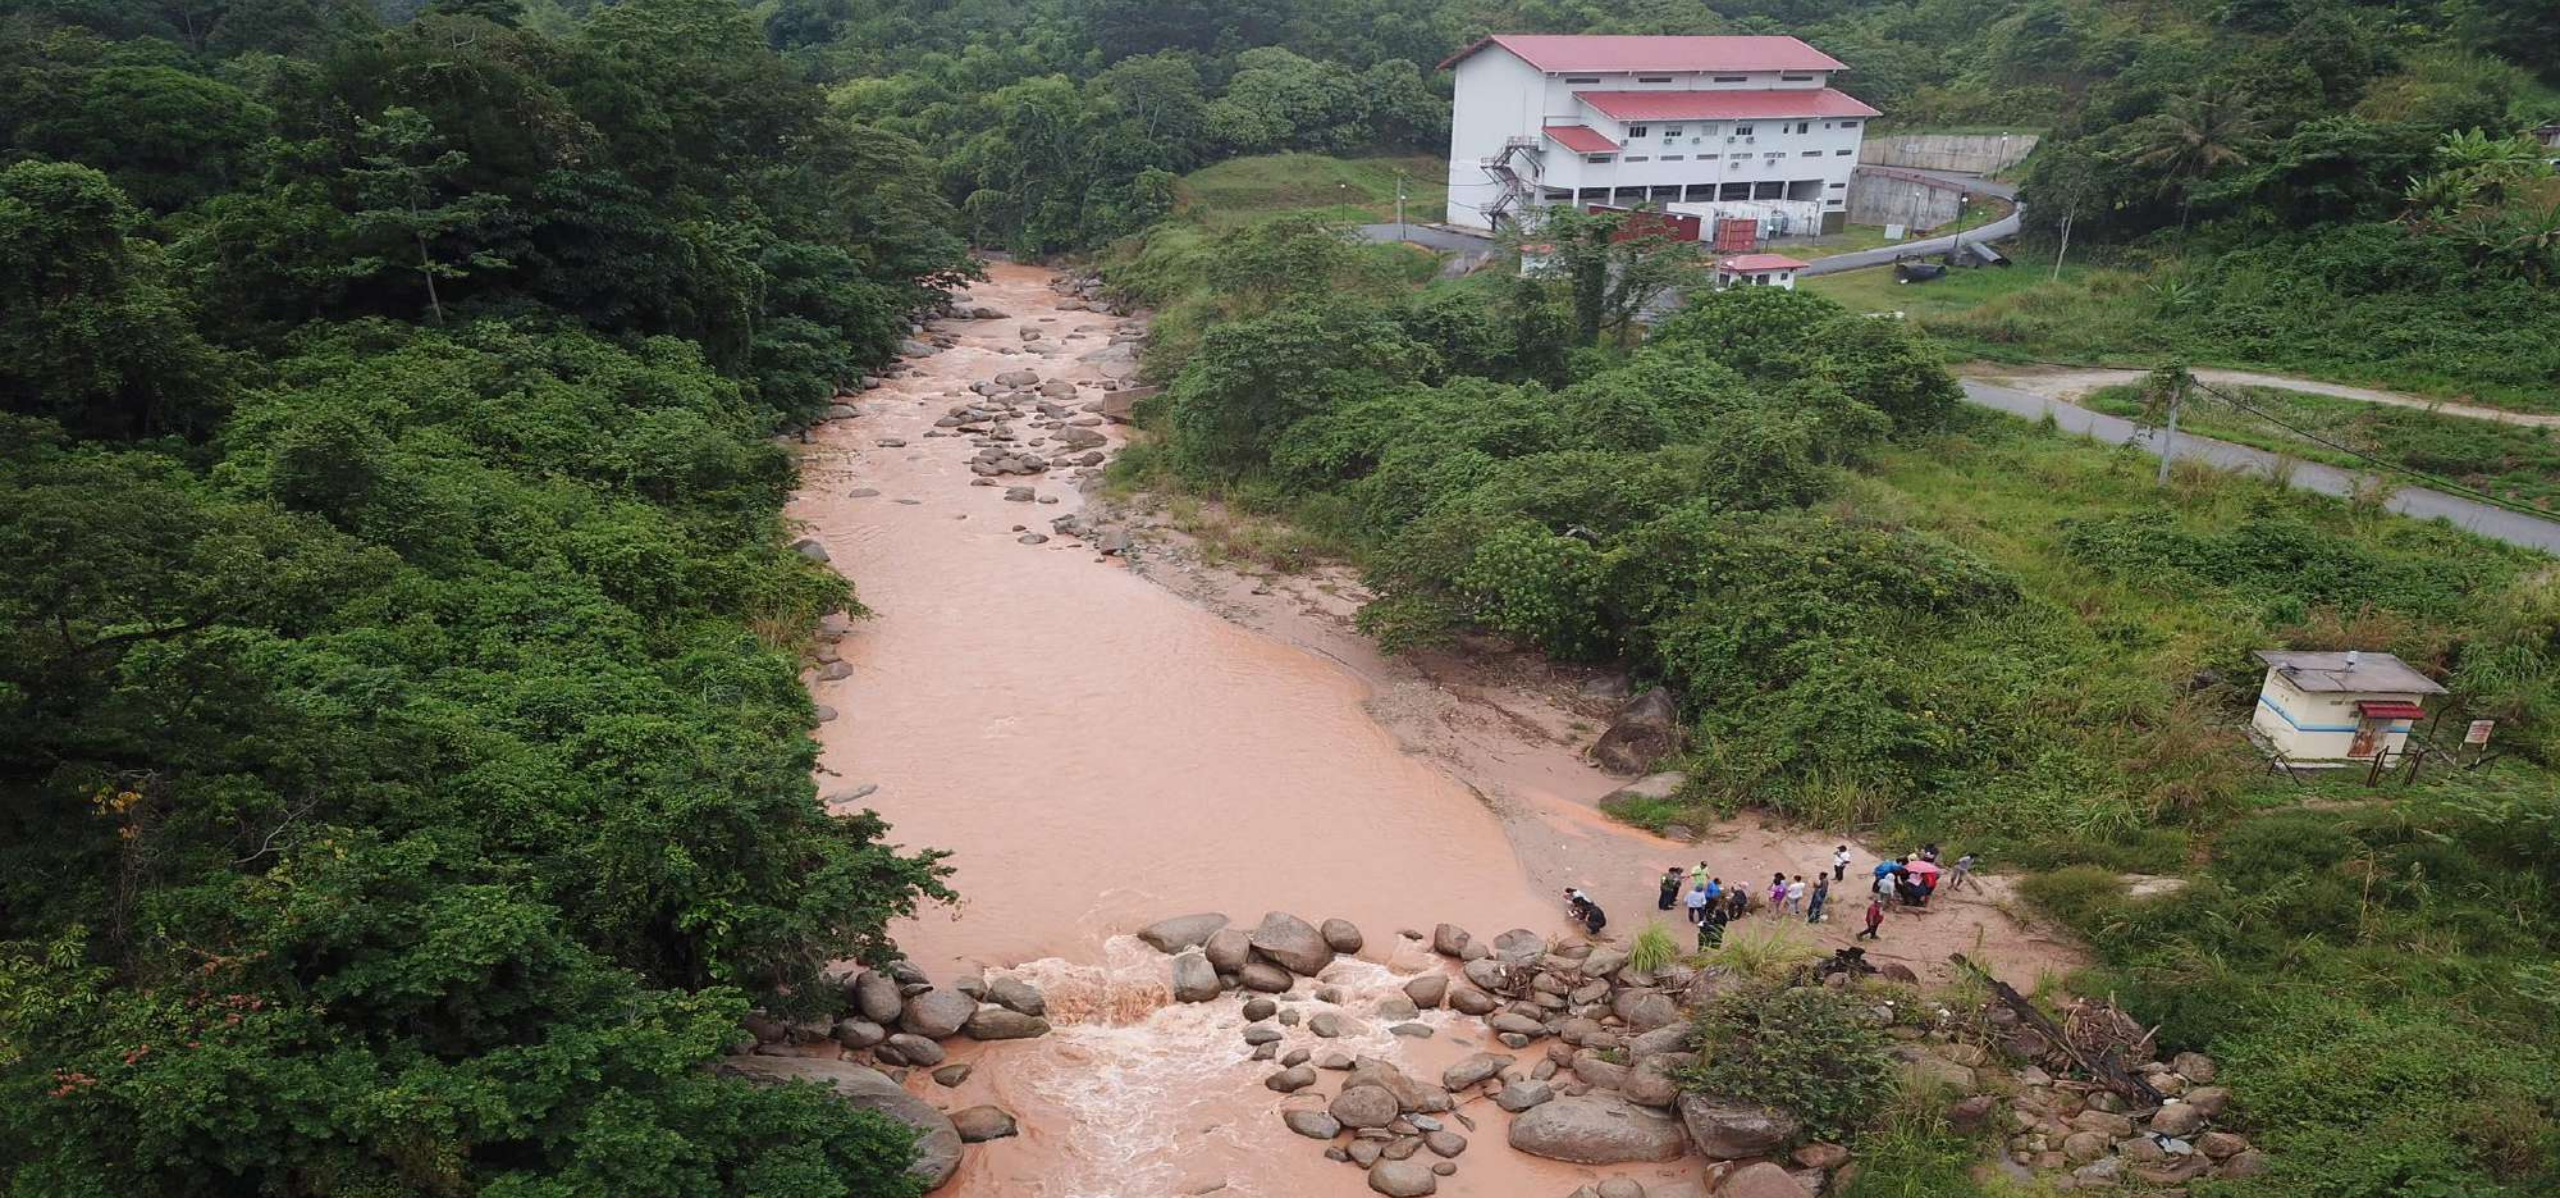
Sungai Belatop condition; Heavily polluted with sediment and nutrient

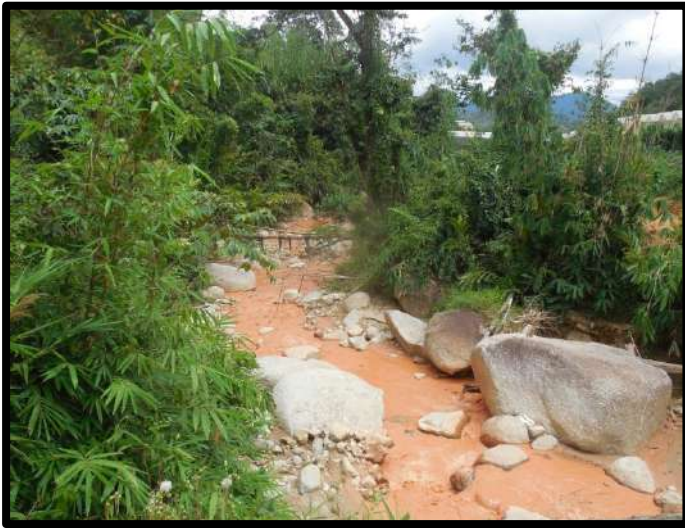
SUNGAI BELATOP

Sungai Belatop condition; Heavily polluted with sediment and nutrient

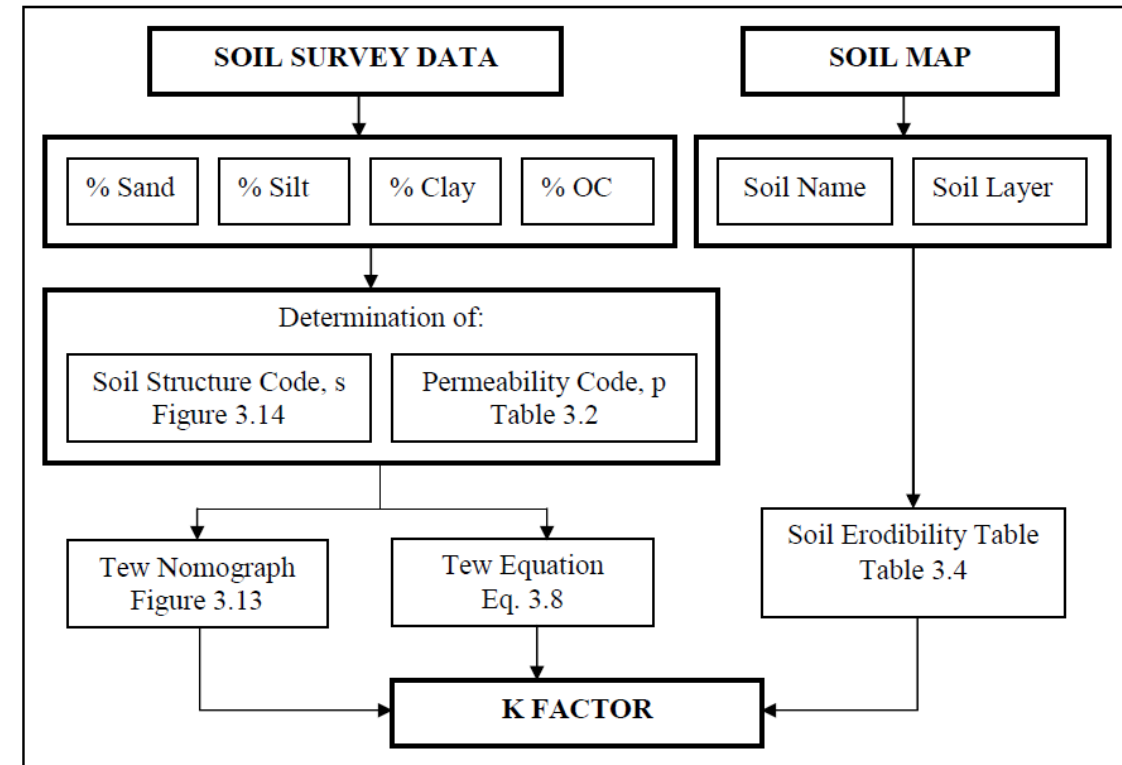
Figure 3.15: Schematic diagrams for determination of K factor

$$K = \left[1.0 \times 10^{-4} (12 - OM) M^{1.14} + 4.5(s - 3) + 8.0(p - 2) \right] / 100 \quad (3.8)$$

- K – Soil Erodability Factor, (ton/ac.)*(100ft.ton.in/ac.hr)
For SI unit (ton/ha)(ha.hr/MJ.mm), the conversion factor is 1/7.59.
- M - (% silt + % very fine sand) x (100 - % clay)
- OM - % of organic matter
- S - soil structure code
- P - permeability class

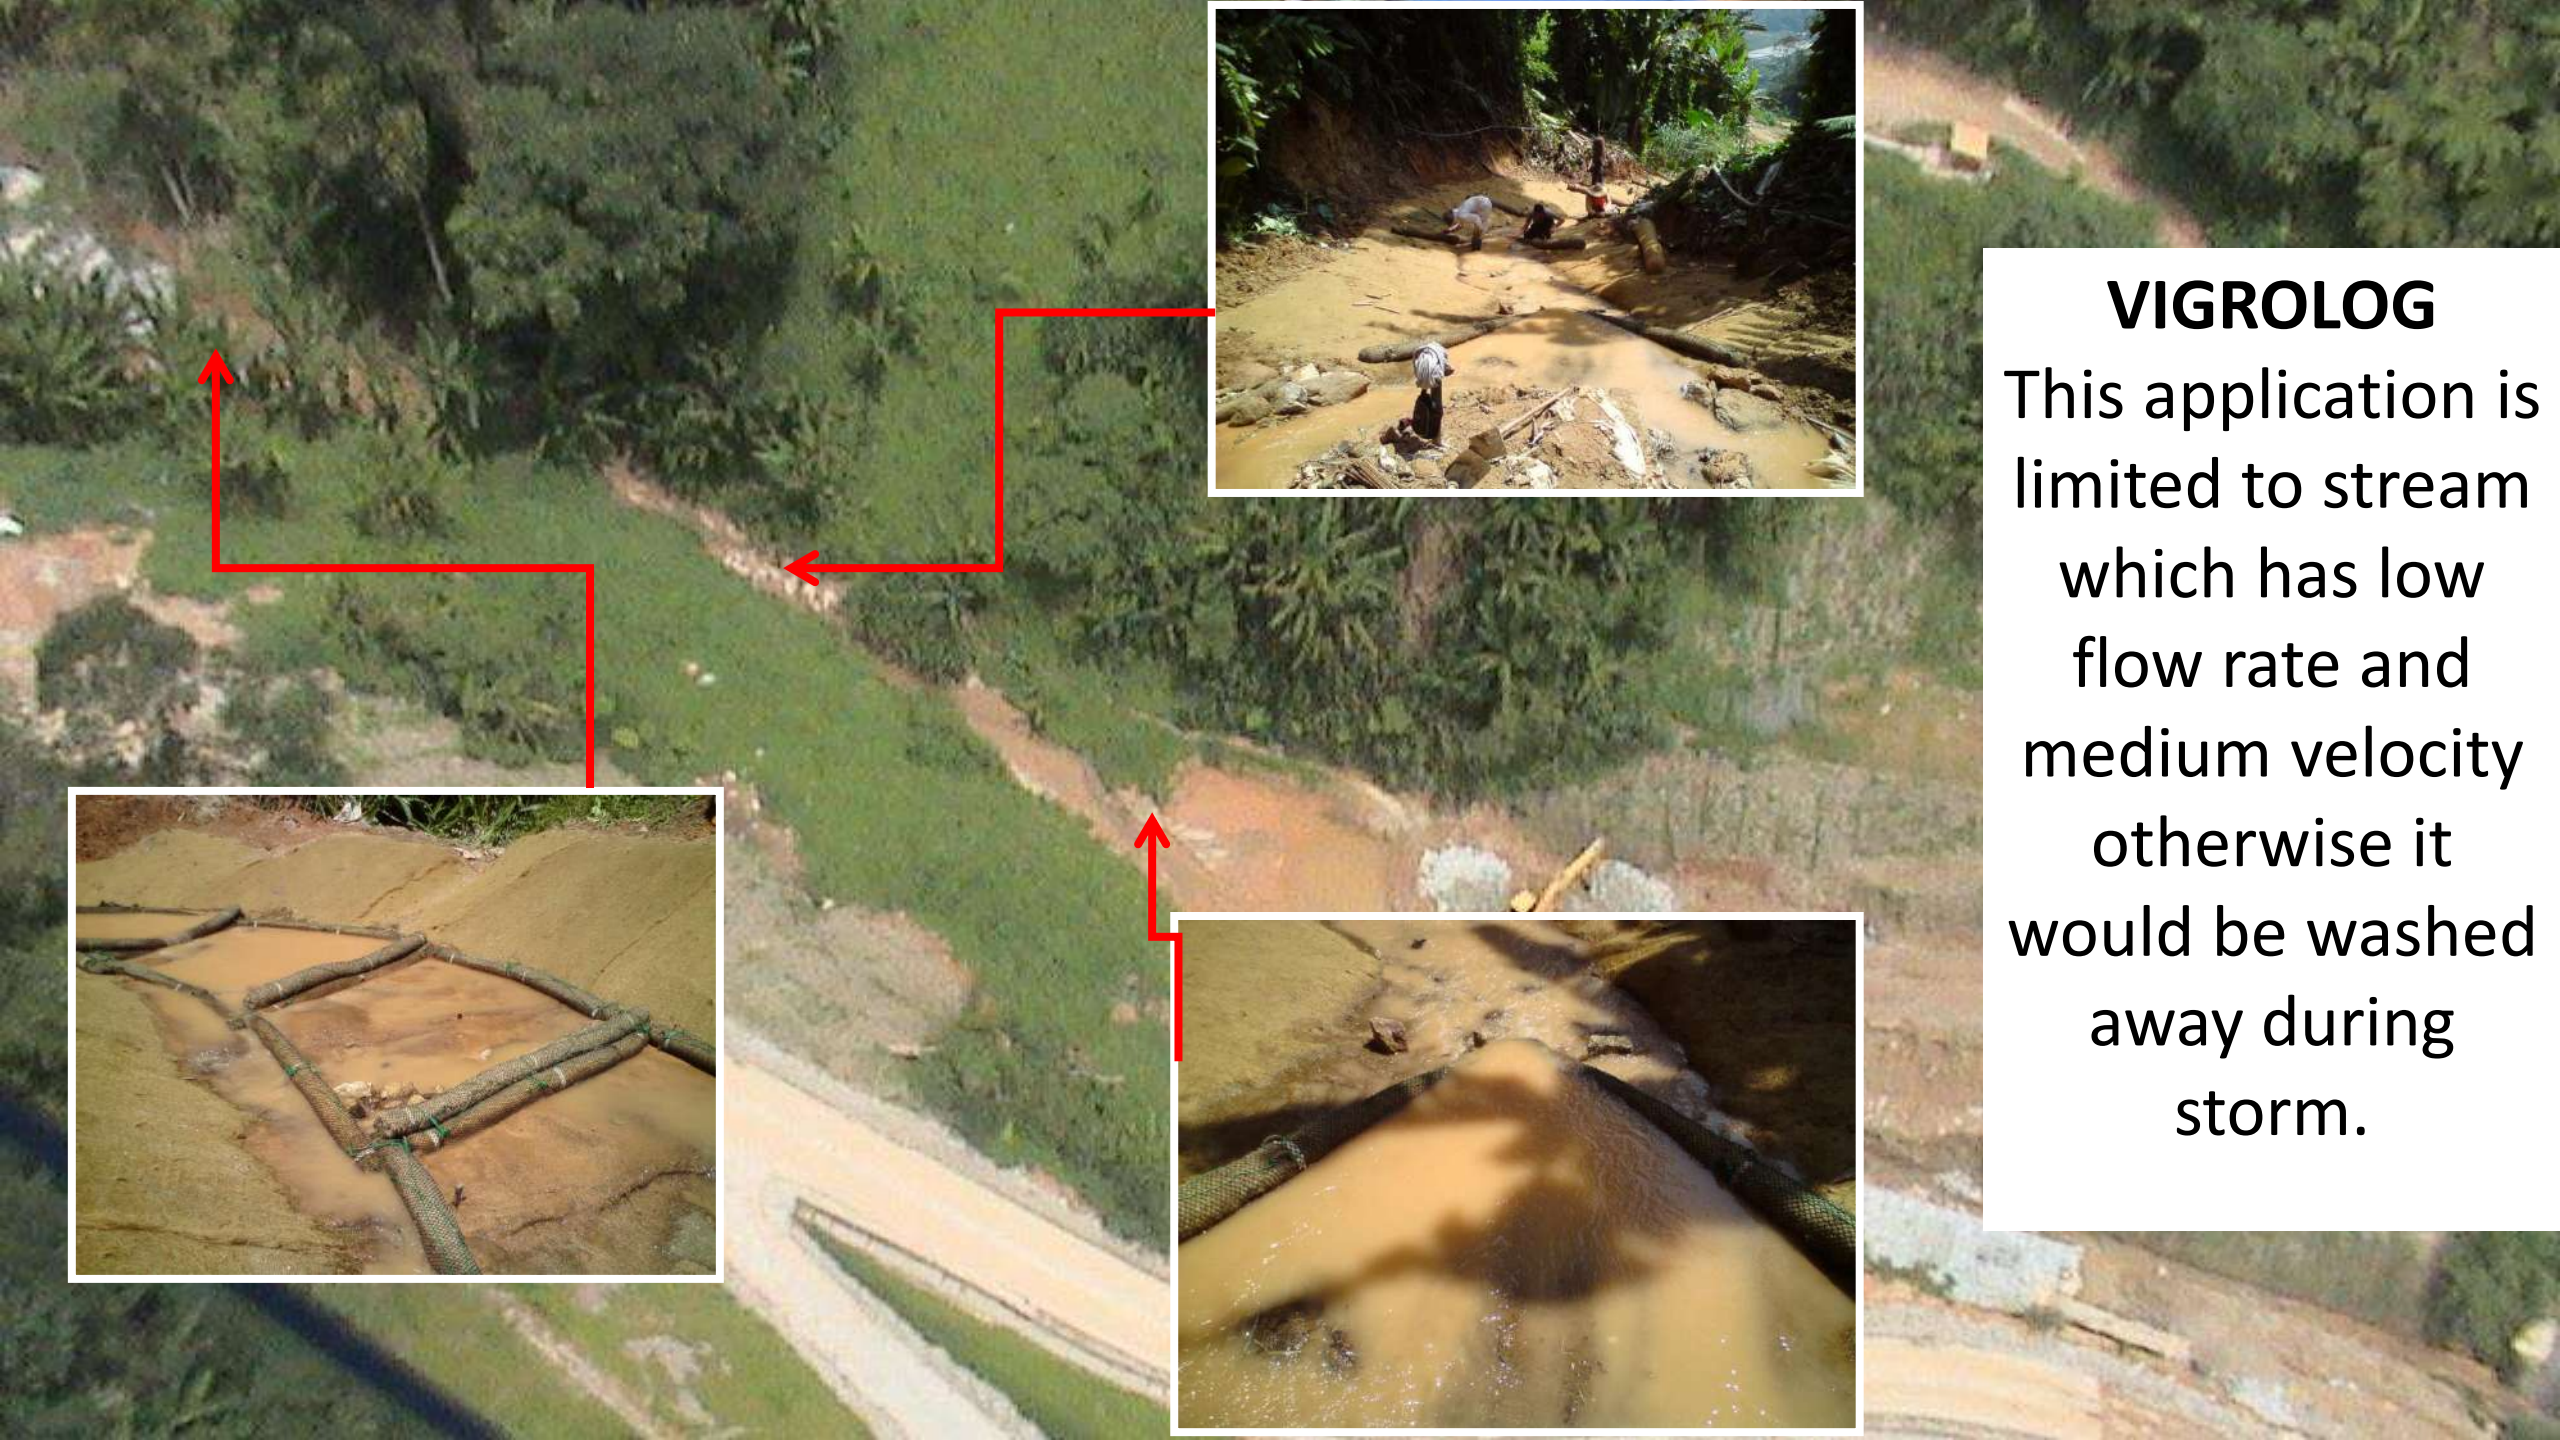
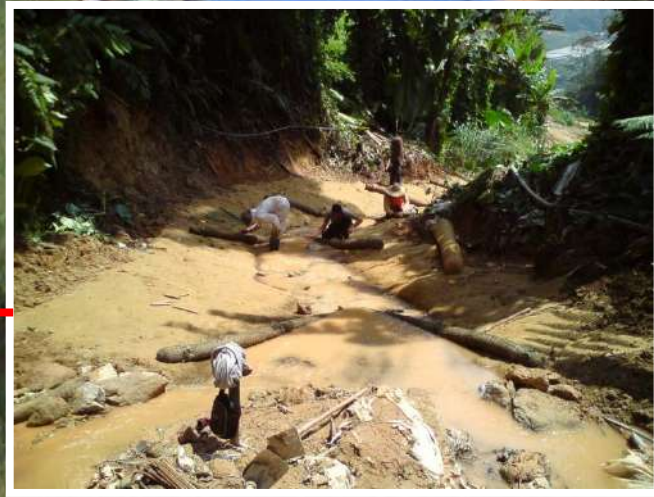
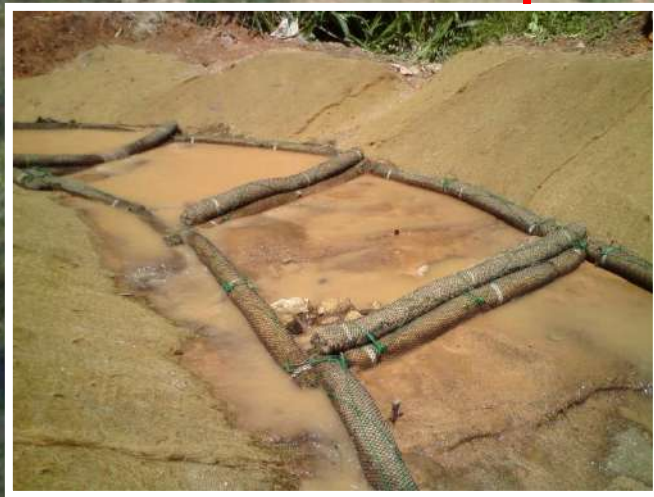
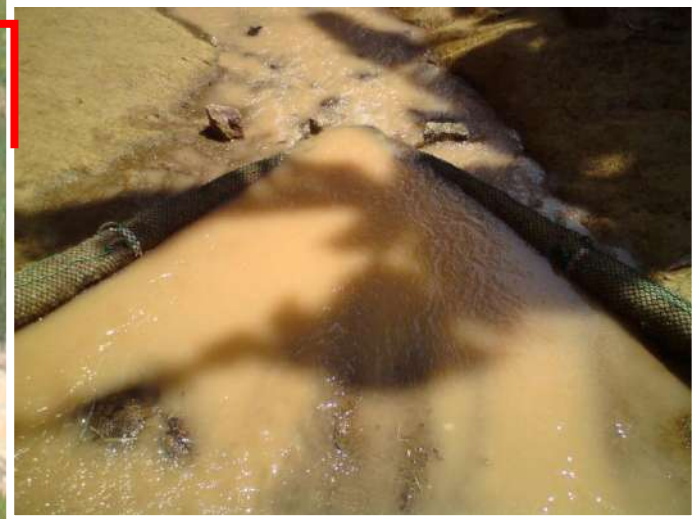
VIGROLOG
This application is limited to stream which has low flow rate and medium velocity otherwise it would be washed away during storm.

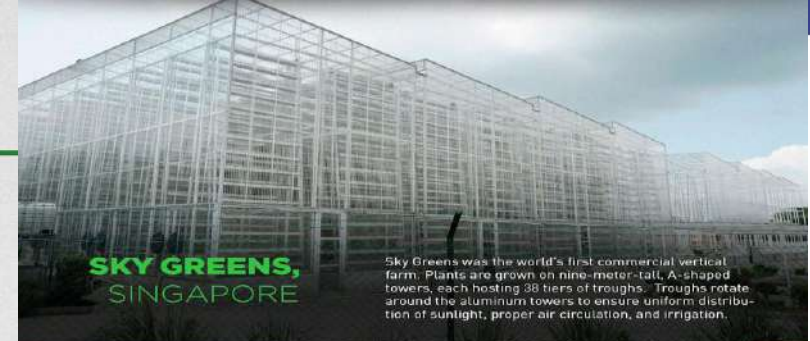
SKY GREENS, SINGAPORE

Sky Greens was the world's first commercial vertical farm. Plants are grown on nine-meter-tall, A-shaped towers, each hosting 38 tiers of troughs. Troughs rotate around the aluminum towers to ensure uniform distribution of sunlight, proper air circulation, and irrigation.

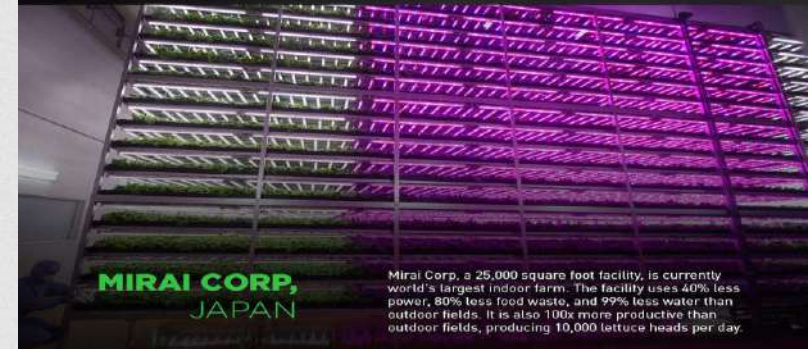
MIRAI CORP, JAPAN

Mirai Corp, a 25,000 square foot facility, is currently world's largest indoor farm. The facility uses 40% less power, 80% less food waste, and 99% less water than outdoor fields. It is also 100x more productive than outdoor fields, producing 10,000 lettuce heads per day.

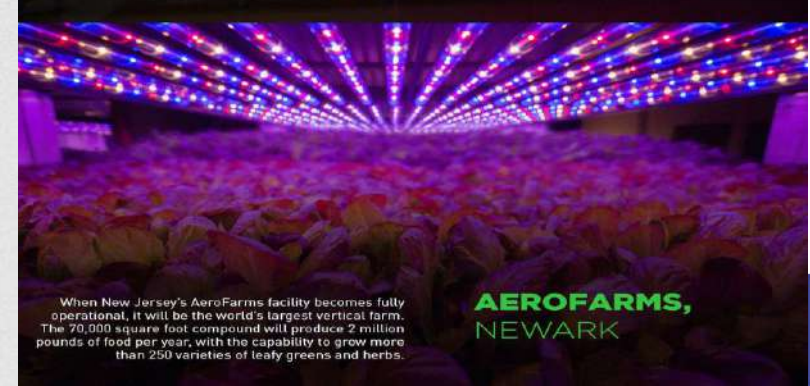
AEROFARMS, NEWARK

When New Jersey's AeroFarms facility becomes fully operational, it will be the world's largest vertical farm. The 70,000 square foot compound will produce 2 million pounds of food per year, with the capability to grow more than 250 varieties of leafy greens and herbs.
