## **Fast, Effective & Economical : Asia and Malaysia's 1<sup>st</sup> Re-directive Solutions for Riverbank Repairs and Water Detention at Sg Pedu, Kedah for agriculture needs in dry season**

Kwok Wing Leong<sup>1</sup>, John McCullah<sup>2</sup>

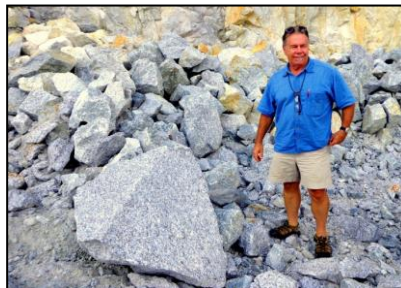
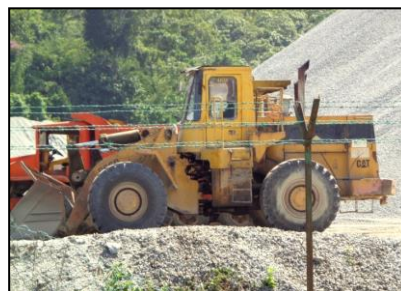
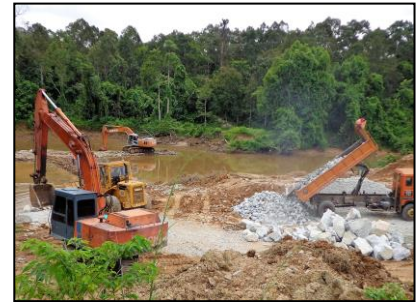
**Material & Equipment Site Visits:**

It was confirmed that the largest rock gradation shall be in vicinity (1) ton as delivery trucks for larger rocks are not locally available and site access poses a major obstacle. The main contractor reinforced several sections and identified specific routing for road accessibility for rock delivery trucks and heavy equipment to the site as most local roads are aggregate base and often dirt road accesses to orchards, padi fields and to the river.

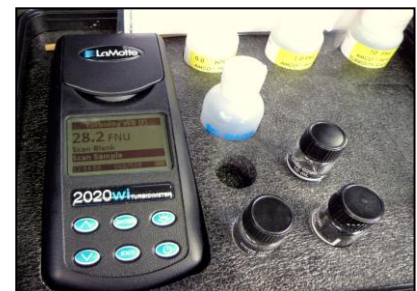
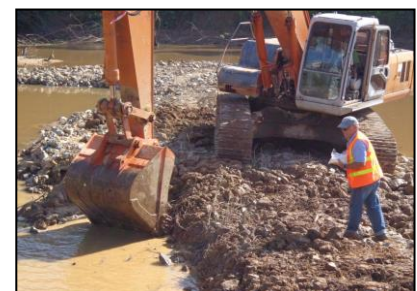
**Water Quality Monitoring and Mitigation Measures:**

As work is conducted at riverbed and riverbank, it is recommended that all work shall cease when water quality readings exceed 50 NTU and mitigations measures applied before recommence. At start work, locations were identified (50m) upstream and downstream of construction site area, where water samples shall be taken (3) times a day during construction from these (2) locations. After daily calibrations, the difference between the downstream and upstream readings of samples shall determine water quality of the workings at the site. Work was stopped on (2) occasions and PE-BMPs (anionic polymer) applied. It was observed on several occasions that water quality upstream has deteriorated outside range of turbidity meter at which case work continued as any mitigation measures would not have made any difference.

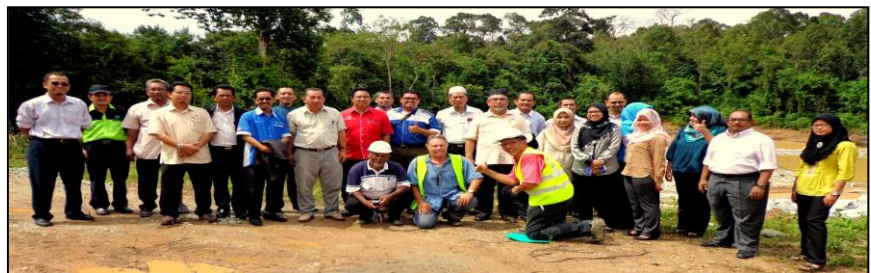
**Work sequence:** 26 August 2017 Re-directive Methods Training and Field Visit. Theory explained in class room setting at UUM and “hands-on” knowledge transfer at site visit.

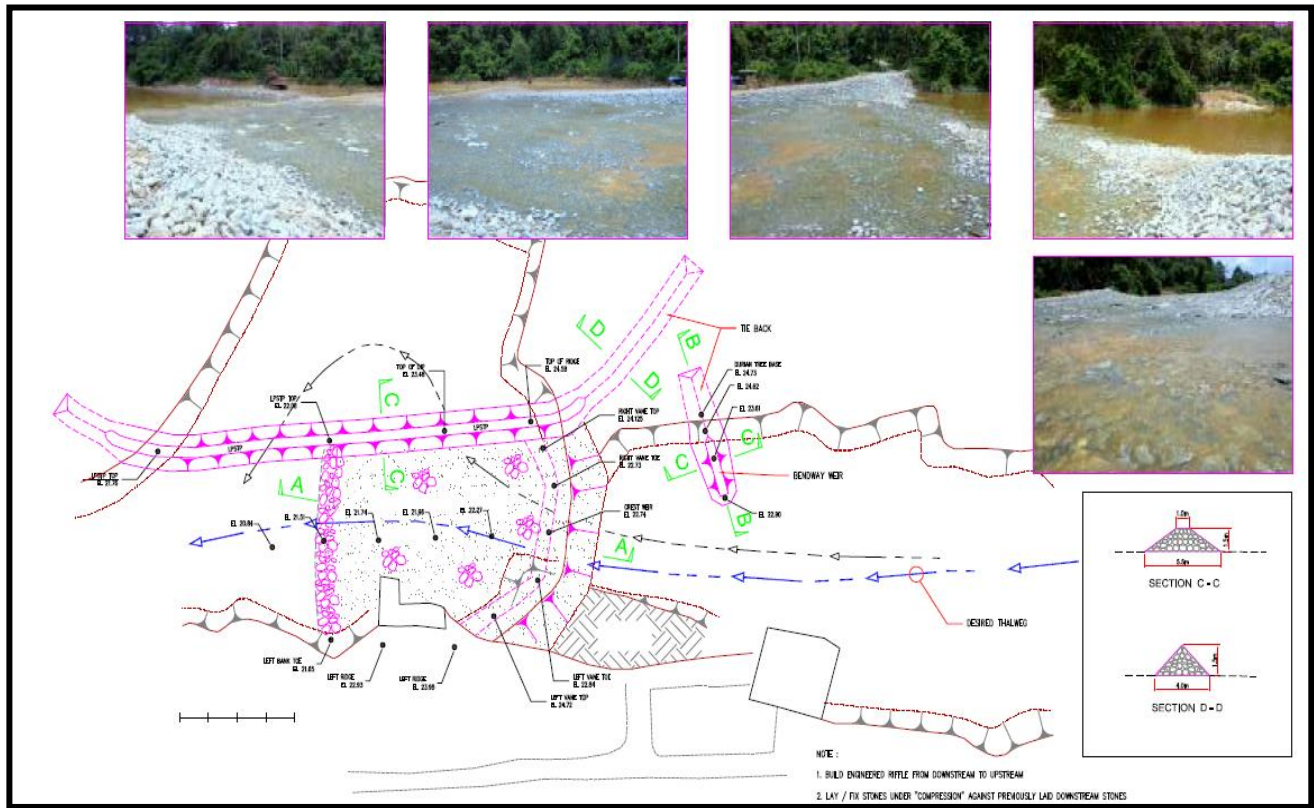
**AS-BUILT DRAWING**

**Summary of Work Progress & Completion:** Work was completed in 5+ weeks and “As-Built” as below. Site visits were made post construction as described below and the project performed well to design aspirations and met the project needs.

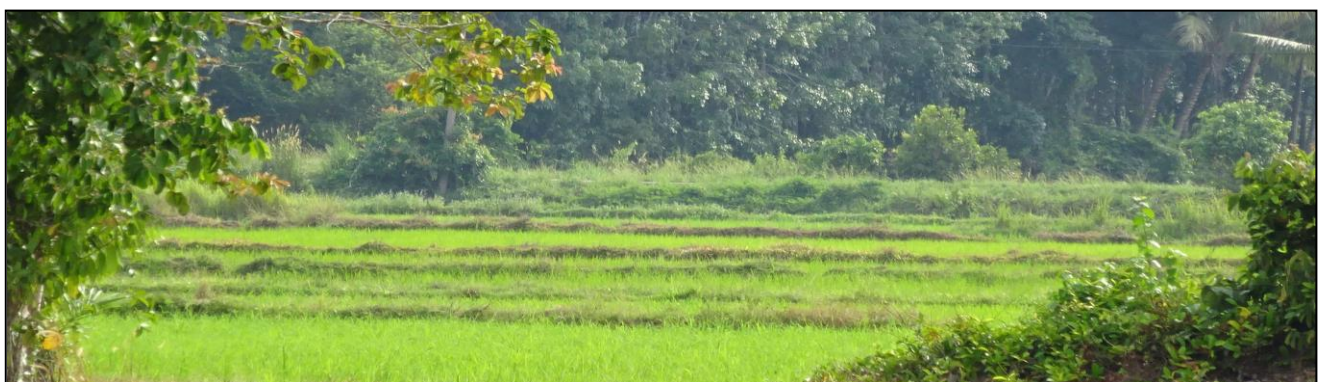
**Quick check on objectives:**

- √ Re-direct thalweg from scouring riverbank onto Newbury Rock Riffle,
- √ Facilitate scoured riverbank “self healing” with aggradation at riverbank,
- √ Riverbank stabilized on both sides after several high water discharges,
- √ Provide “life-blood” to agriculture with 2m water retention from Newbury Rock Riffle,
- √ BMPs to maintain water quality during construction,
- √ Provide training to state of Kedah engineers and “hands-on” site visit during construction
- √ Return this section of river back to its natural “proper function condition” (PFC), improve water aeration and habitat for fishes.
